The 3<sup>rd</sup>  
Thailand Symposium on  
Earthquake Research

## M7.7 2025 Mandalay Earthquake

Response of Myanmar Earthquake Clinics

Myanmar Earthquake Clinics

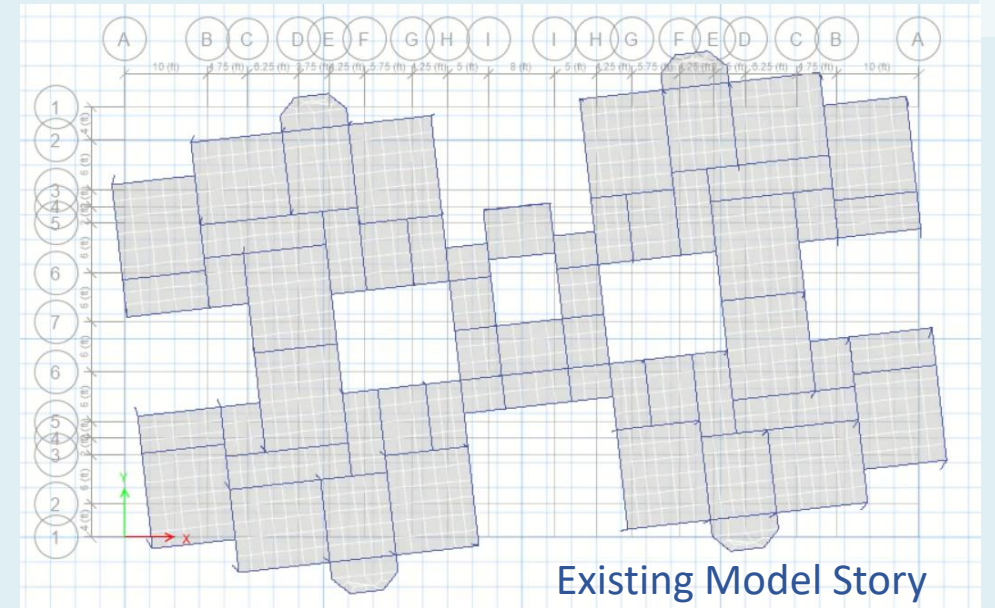
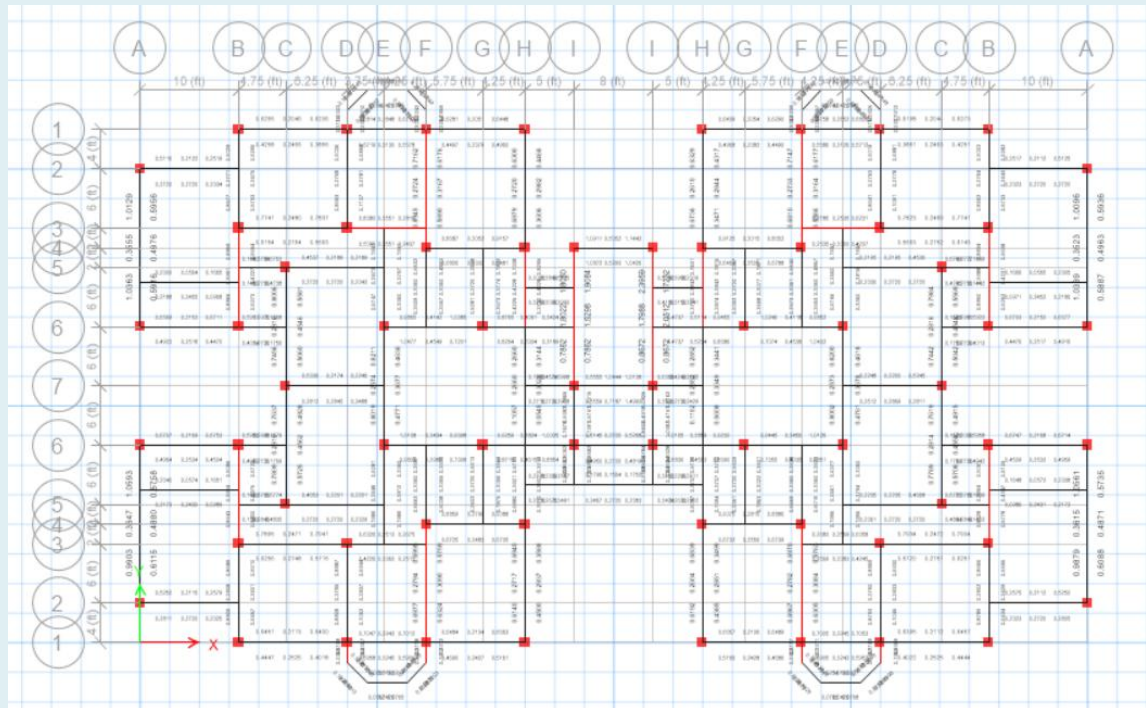
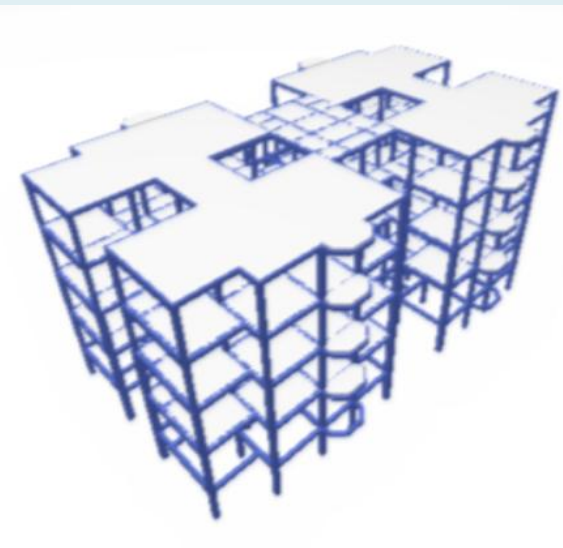
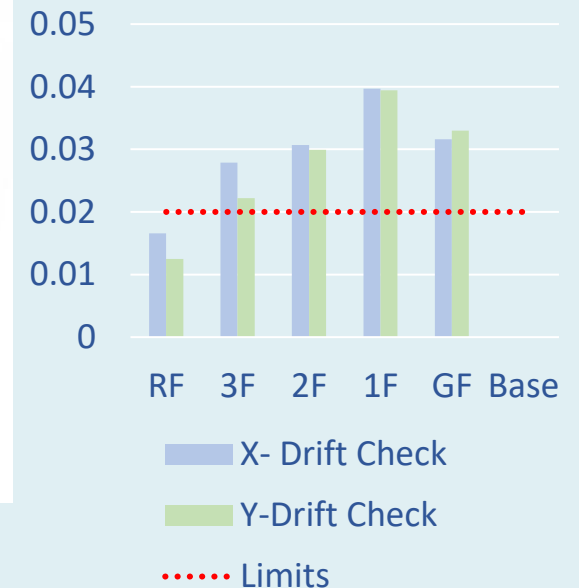
- No Lateral Force Resisting System
- First mode in rotation
- Drift limit exceed
- Many concrete columns are failed in design check.
