# Preliminary Reflections from the New Zealand Learning from Earthquakes Delegation

Catalina Miranda<sup>1\*</sup>, Andrew Stolte<sup>2</sup>, Jitendra Bhatta<sup>3</sup>, Andrew Baird<sup>4</sup>, Lucas Hogan<sup>2</sup>, Jitendra Bothara<sup>5</sup>, and Chungwook Sim<sup>6</sup>

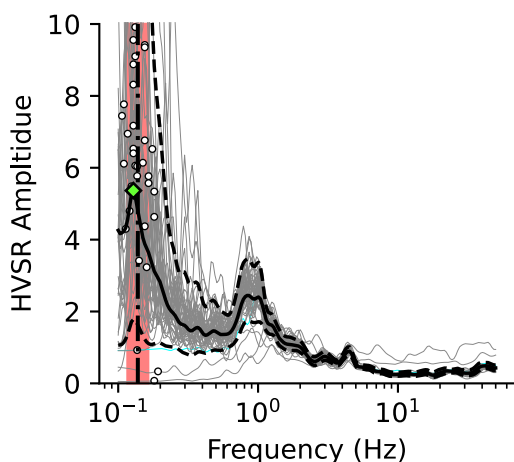
As a part of the NZ learning from earthquakes teams' efforts to document 10 case history buildings, the foundation-level and uppermost story of the buildings were temporarily instrumented using portable broadband seismometer stations, consisting of a Nanometrics Pegasus Digitizer and a Nanometrics Trillium Compact Horizon 120s Sensor. This equipment has a flat response to velocity between a period of 120s and a frequency of 200 Hz (0.005s), enabling the measurement of the deep sedimentary basin response and the long-period response of tall buildings in Bangkok. The data was processed using hvsrpy [6] an open-source Python package. An example of the mHVSr spectra from microtremor measurements in the basement of one case history building are shown in Figure 1, with a median  $T_0$  estimate of 7.2 s

Figure 1 mHVSr spectra of microtremor recordings at foundation level. The solid black and dashed black lines indicate the mean and +/- standard deviation bounds of the mHVSr spectra. The green square indicates the median  $T_0$  estimate, the red shaded area indicates +/- 1 lognormal standard deviation.

Preliminary mHVSr analysis indicates site period ranges from 4.5 to 7.6 seconds across the ten case history sites. However, further analysis is needed to determine if the deep foundation of the buildings obscures the longer period peaks at a few of the sites.

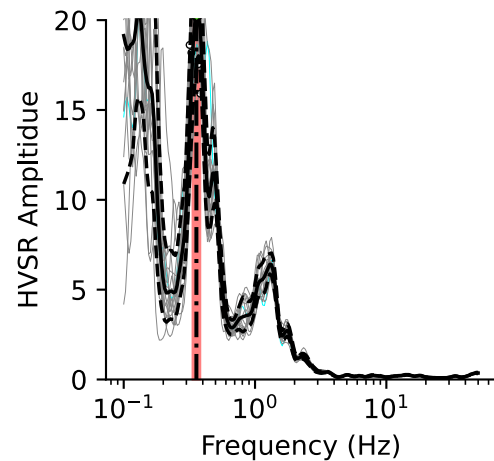
Additionally, mHVSr analysis was used to estimate the fundamental period of the buildings from the ambient vibration recordings on the highest floors. An mHVSr spectra from the example site is shown in Figure 2. The estimated period is 2.8 s for the 25-storey building.

Figure 2 mHVSr spectra of microtremor recordings on the 25th floor. The solid black and dashed black lines indicate the mean and +/- standard deviation bounds of the mHVSr spectra.
