# FRAGILITY OF LOW-RISE RC MOMENT FRAMES IN NORTHERN THAILAND: OBSERVATION FORM THE 2025 MANDALAY EARTHQUAKE

Arnon Sunatai<sup>1</sup>, Jarun Srechai<sup>2</sup>, Wongsu Wararuksajja<sup>3</sup>, Sutat Leelatawiwat<sup>\*1</sup>

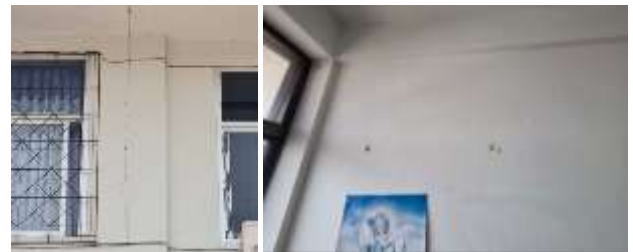
Slight Damage

For the purpose of this study, data from buildings between 1 and 6 stories were used to represent low-rise buildings in the area. The majority of the damage occurred in infill walls, with only minor structural damage observed in a few exceptional cases. This limited structural damage is likely due to the relatively low level of ground shaking. Field observations were compared with existing experimental results for reinforced concrete (RC) frames with infill walls. Based on this comparison, story drift values were estimated for each documented damage state. These results are summarized in Table 1. Figure 1 provides examples of damage corresponding to each documented damage state.

Fig. 1. Observed damage and classification (Source: Chiang Mai Municipality) [1].
