# SOME OBSERVATIONS FROM THE M7.7 MYANMAR EARTHQUAKE ON MARCH 28, 2025

Chatpan Chintanapakdee<sup>1,\*</sup>

<sup>1</sup> Chulalongkorn University, Bangkok, Thailand

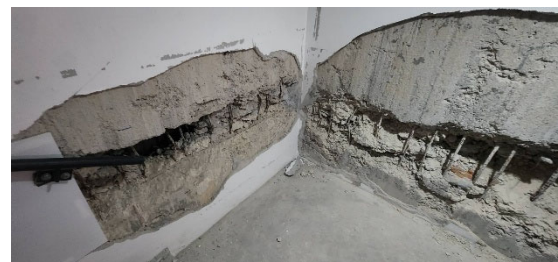
Many tall buildings had compression failure of RC walls visible from outside of the buildings. Concrete crushing was obvious and some rebar buckling occurred in many cases. Such damage could be due to high stress concentrations at some locations in the buildings, mostly around mid-height and some near the ground floor, or could be due to construction defects, i.e., poor concrete strength because of poor handling or lack of curing. A 25-story building had its 300-mm thick RC wall crushed so severe that there are some big holes through the wall. Fortunately, the remaining part of the wall can still carry the high vertical load in such a tall building. Such distress in main structural components means that the gravity load must have been carried by the nearby members where stress would be higher than usual and the safety margin against future earthquakes would be significantly compromised.

Some buildings suffered loss of load carrying capacity such that the floor elevation became lower than before the earthquake hit and this spoiled building normal operations and occupancy. Typically, the elevators of tall buildings are

very sensitive to the alignment of RC core walls. Many elevators must be shut down and are still awaiting corrective actions before they can return to normal operation. Some tall buildings have lost more than half of number of elevators, so the vertical movement in the building becomes problematic and ensues very long wait time.

Figure 1. Concrete Crushing in RC Wall of a 25-Story Building in Bangkok

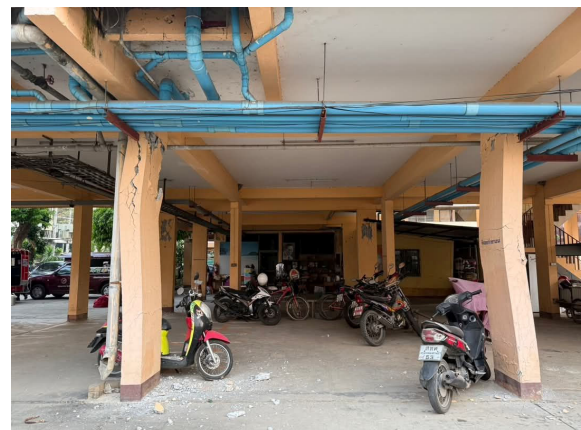
An 8-story building in Chiangmai, which is considered a high seismic zone, suffered column buckling at many locations. It is noticeable that the tops of these columns are not properly braced by beams as the beams were not aligned along the gridlines of columns. This echoes the importance of having beams bracing all column heads to control the rotation and sway of the columns. Such inappropriate locations of the beams cause the lack of moment-resisting frame action so there is inadequate lateral force resisting system in this building. This type of design should be prohibited in seismic prone areas.

Figure 2. Column Buckling in an 8-Story Building in Chiangmai

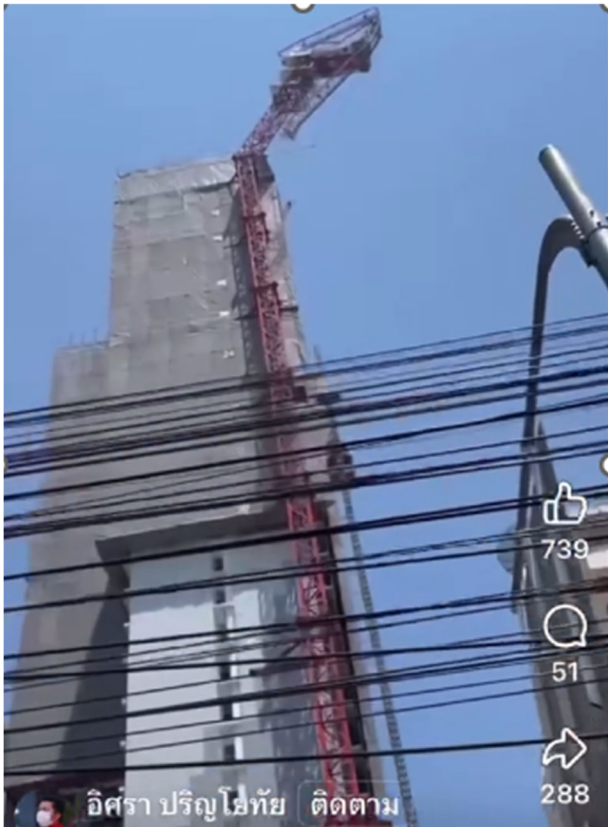
Besides the structural damage mentioned above, construction equipment like tower cranes had toppled down in many locations. Such failure inevitably caused life of the operator right away. The free-standing unbraced height may be too high, or the tower structural member and connections were not adequate to resist the lateral load. Such incidents called for improving standard of practice of this equipment.

Figure 3. A Construction Tower Crane Toppling in Bangkok

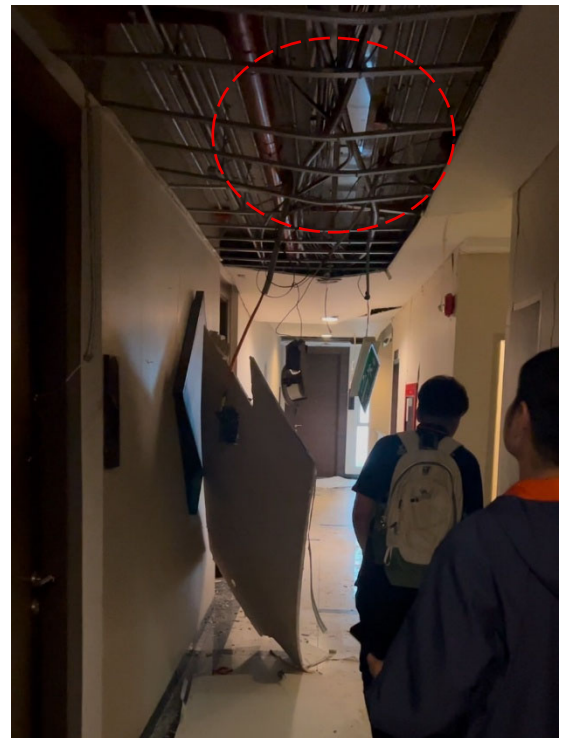
Majority of tall buildings in Bangkok experienced at least some damage in non-structural components. Several cracks in masonry walls occurred in many tall and midrise buildings in Bangkok. Wall tiles fall are also commonly found. In addition, gypsum ceiling was often found to be damaged and fell in many tall buildings. This could obstruct evacuation in case of emergency. By looking closely at the remaining ceiling frame, the fall was due to buckling of the ceiling frame causing screws to be pulled out of the gypsum board. In the future, a better connection type is warranted to ensure that occupants can evacuate safely.

Figure 4. Ceiling Falls in Many Buildings in Bangkok
