The 3<sup>rd</sup>  
Thailand Symposium on  
Earthquake Research

## M7.7 2025 Mandalay Earthquake

Response of Myanmar Earthquake Clinics

Myanmar Earthquake Clinics

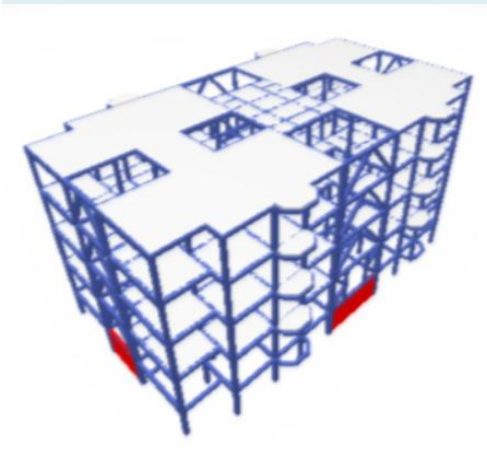
- System Improvement:
  - Add Lateral Force Resisting Frames in re-entrant corners
- First and second modes in translation
- Drift within limit
- All structural members passed in design check.

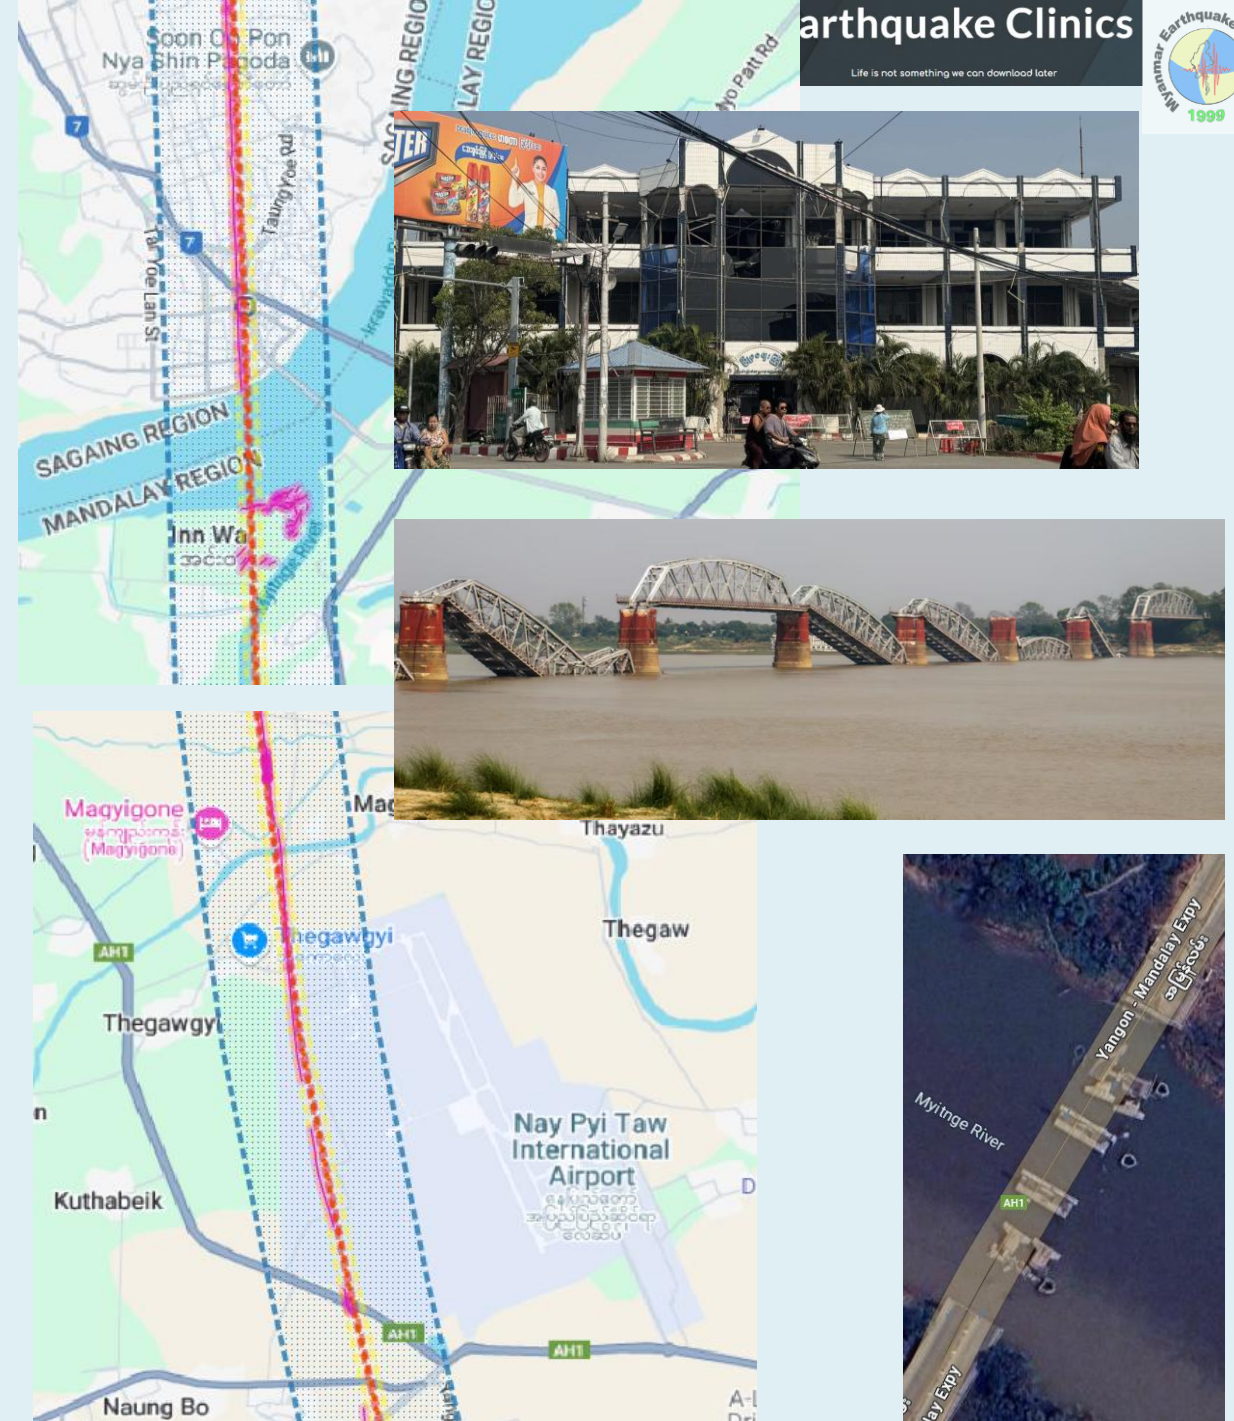
- Sagaing market
- Sagaing bridge
- Myitnge bridge
- Mandalay International Airport
- Naypyitaw Ottarathiri Hospital
- Naypyitaw Airport
- Etc.
